PAJINGO | GOLD MINE | PASTE THICKENER

PROJECT OVERVIEW

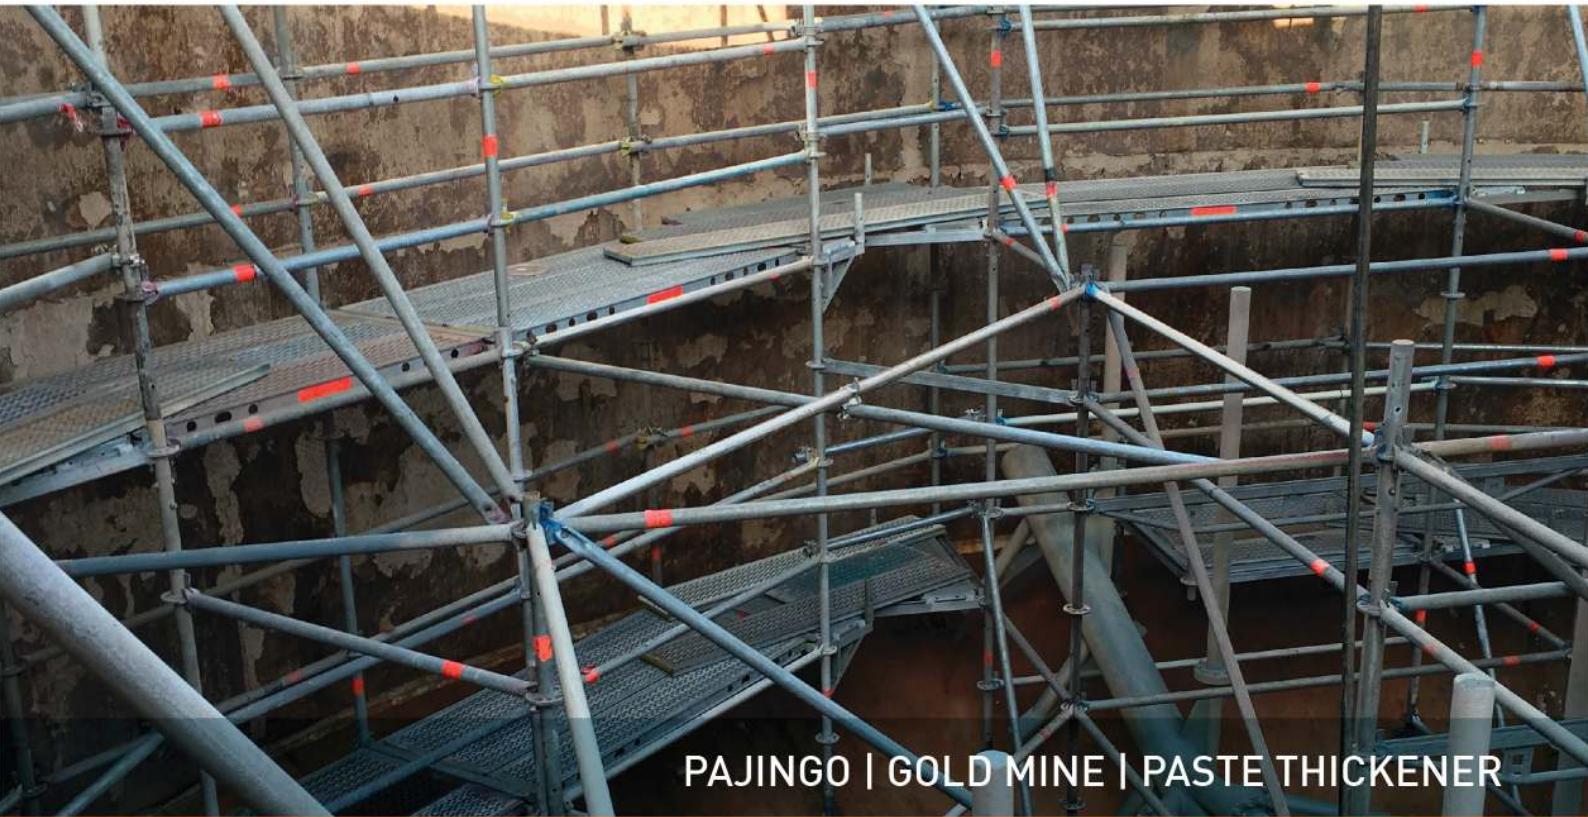
Circular scaffolding is normally very simple when using the Layher Scaffolding system but is more challenging when the floor of the thickener is on a 45-degree slope and is extremely slippery.

The challenge was to install the scaffolding quickly and efficiently during a shutdown period to allow a full refurbishment including blast and paint. The scaffolding needed to be designed to be self-supporting to stop it sliding down the slope.
